FLOOD PROOFING PERFORMANCE

Successes
&
Failures

**US Army Corps
of Engineers®**

December 1998

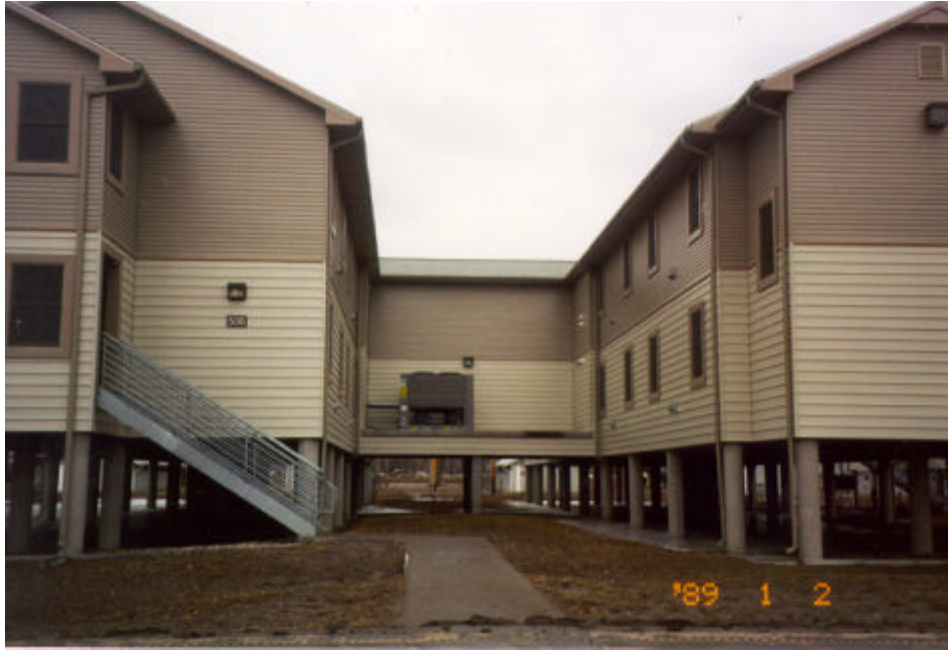
During the 1997 flood event, about 3 feet of floodwater inundated the area beneath the elevated buildings. Massive ice blocks also floated beneath the elevated buildings, directly impinging upon the posts. Floodflow velocity was moderate. No damage occurred due to either floodwater or the impact of the ice blocks.

Lesson. This flood proofing system performed very well in this flood event. The buildings were elevated enough to be above the flood elevation and the posts were strong enough to withstand the impact of floating ice blocks without damage. Erosion was not a factor for the event.

Looking at one of the elevated buildings.
